**Federal budgetary institution  
«Administration of the Volga-Baltic inland waterways basin»**

**«Reconstruction of the hydraulic facilities of the Volga-Baltic Waterway»**

**Lappeenranta, 22.01.2014**

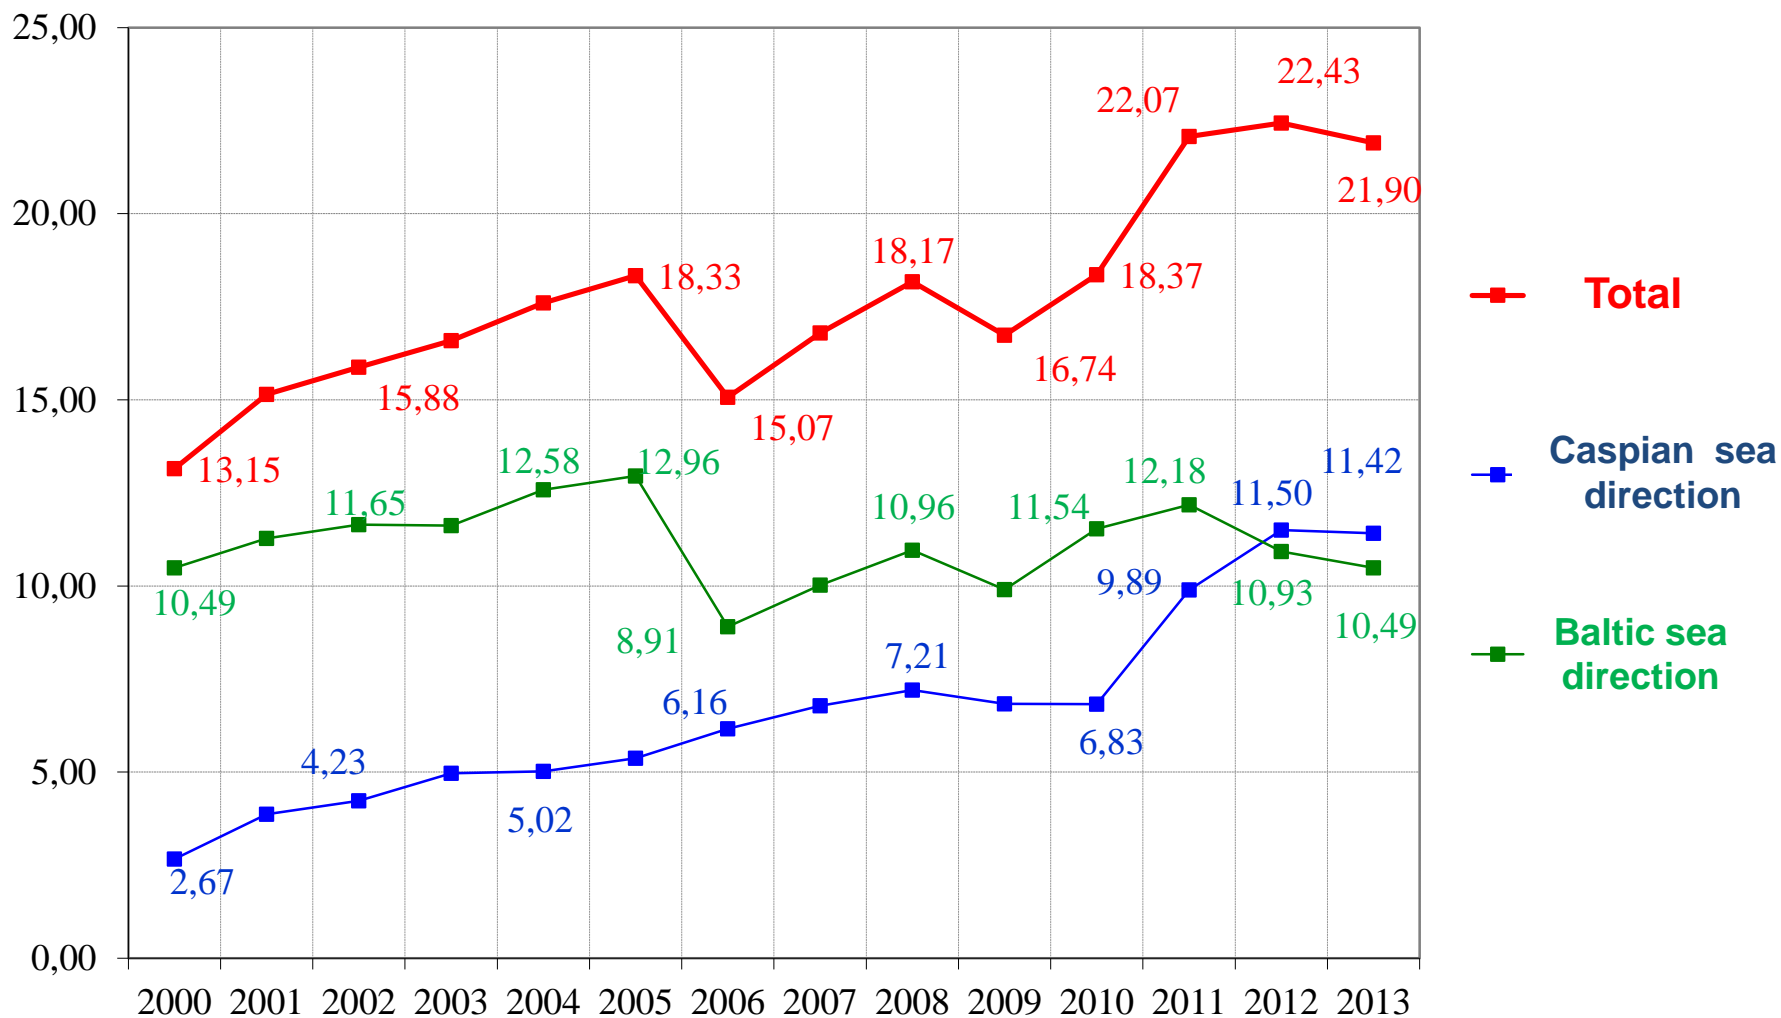
## Cargo traffic through the Volga-Baltic waterway 2000 ÷ 2013

Million tons

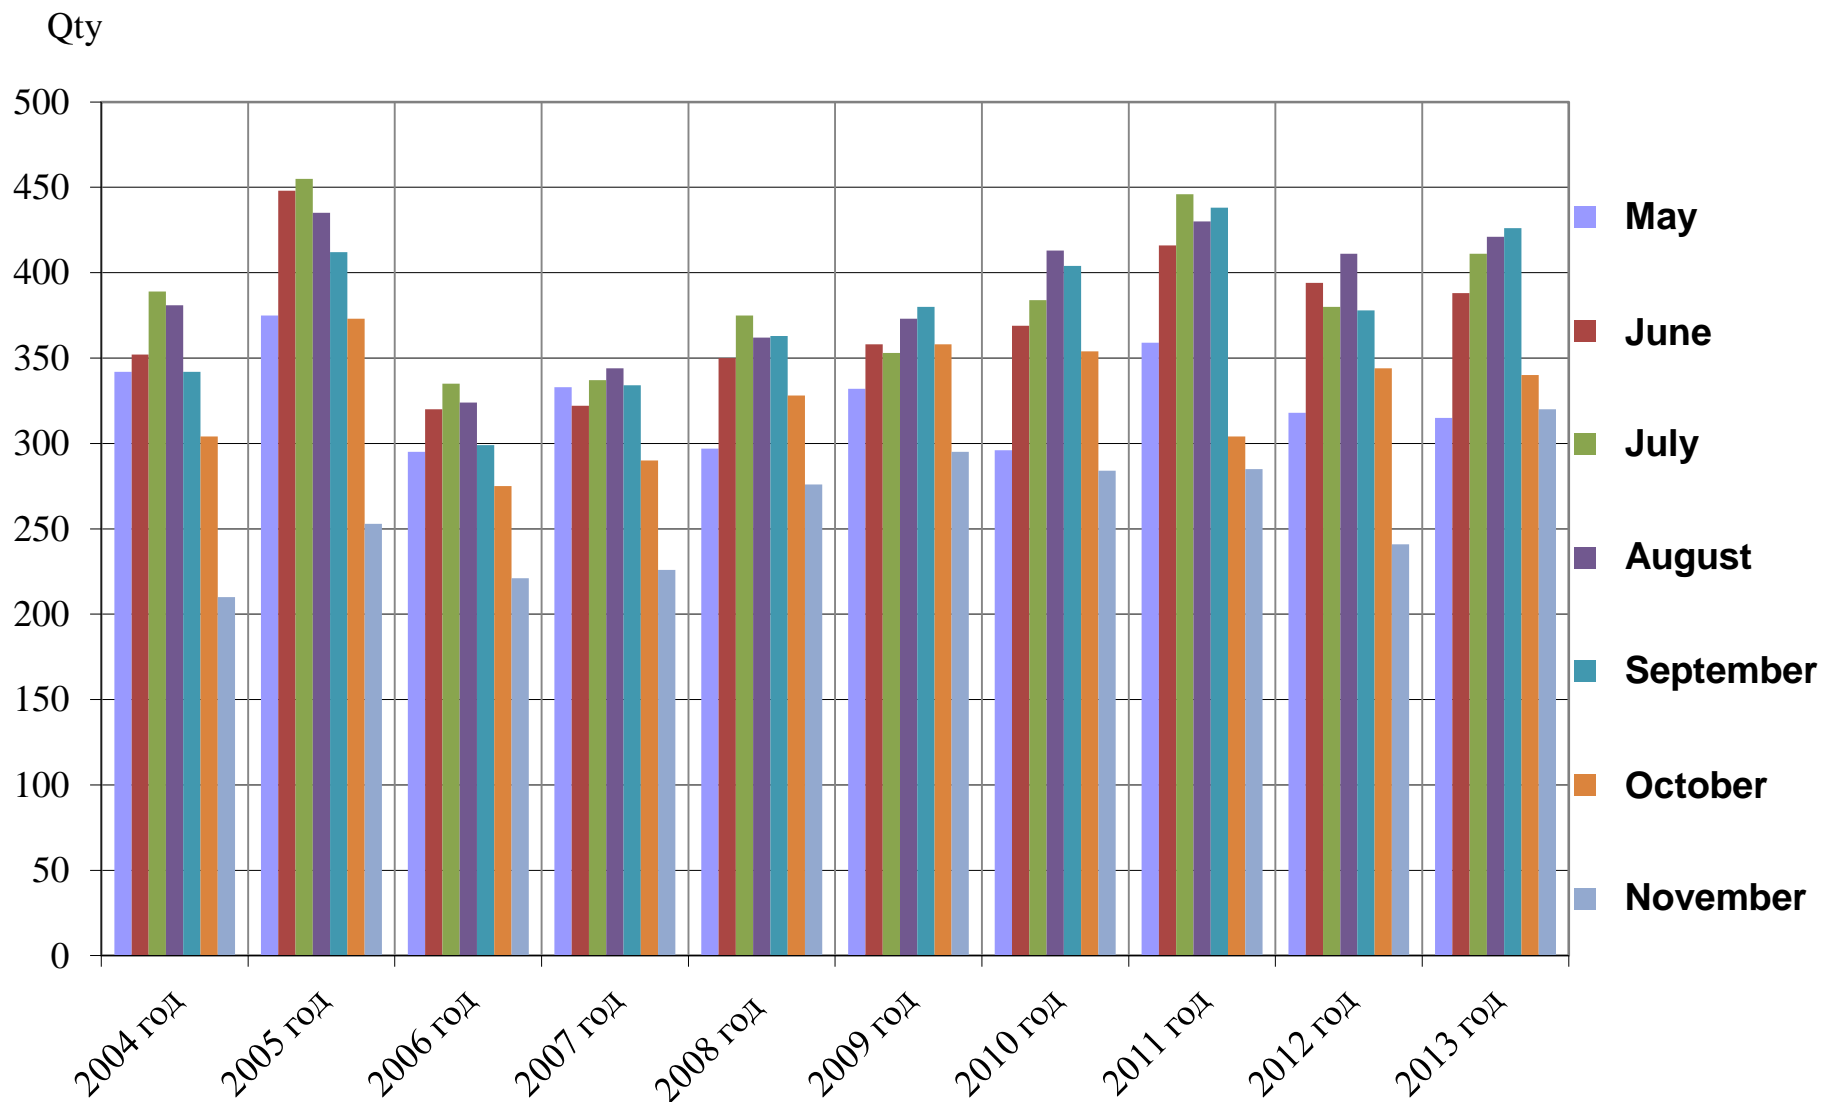
## Ceiling amount of vessels on the main Volga-Baltic waterway tracks

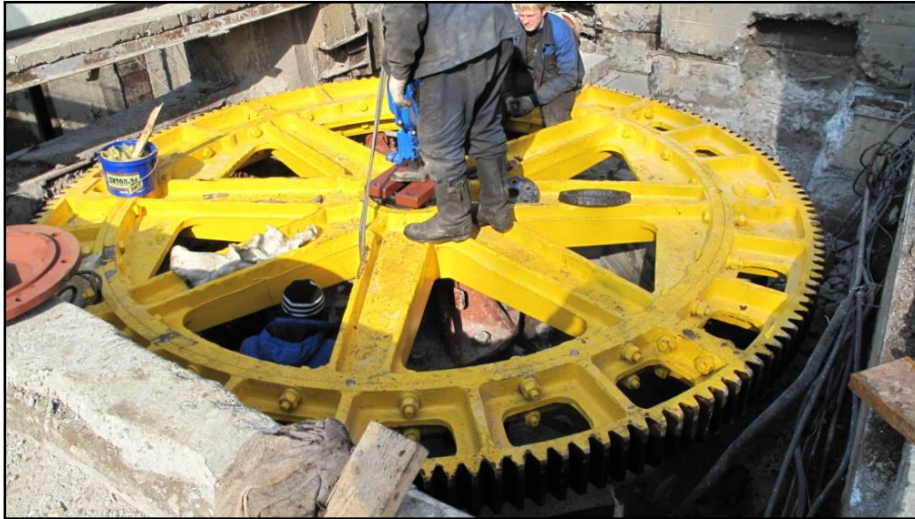
**All the gate engines, paddle engines and metalware have been replaced**

**Gate engines**

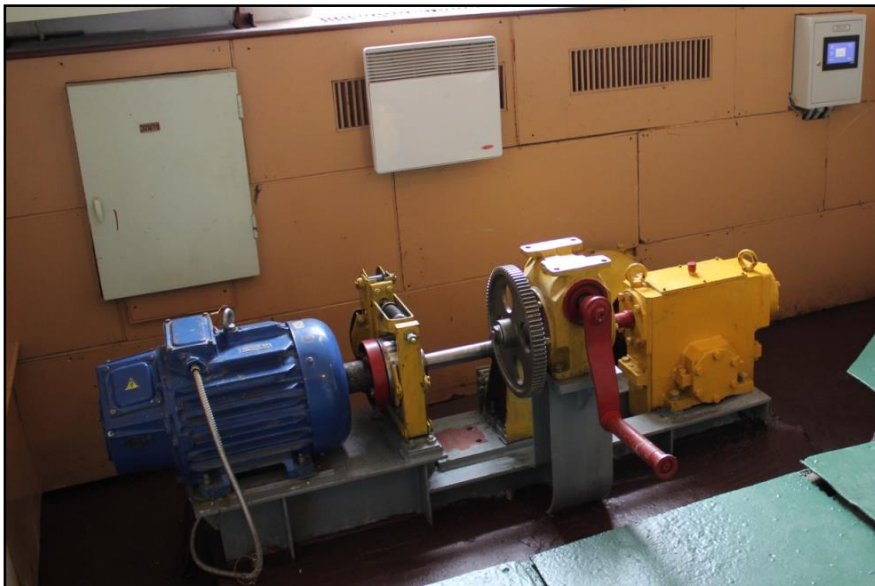
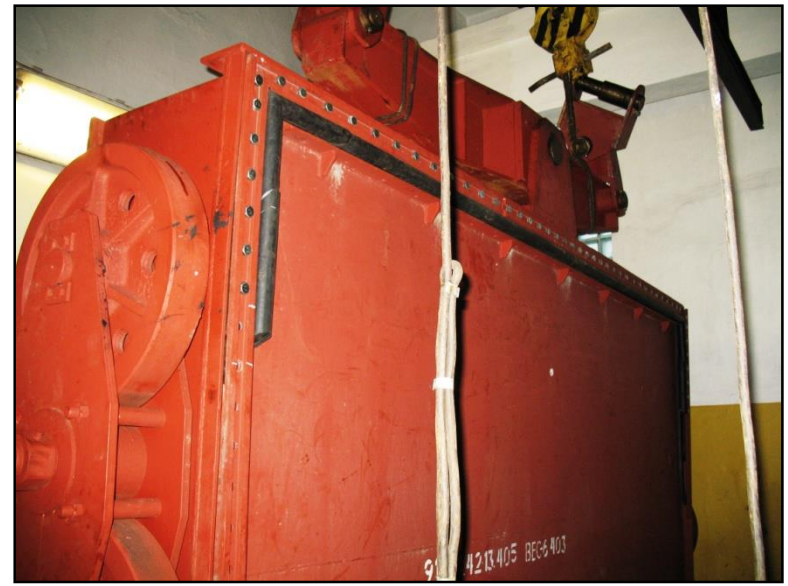
**Paddles**

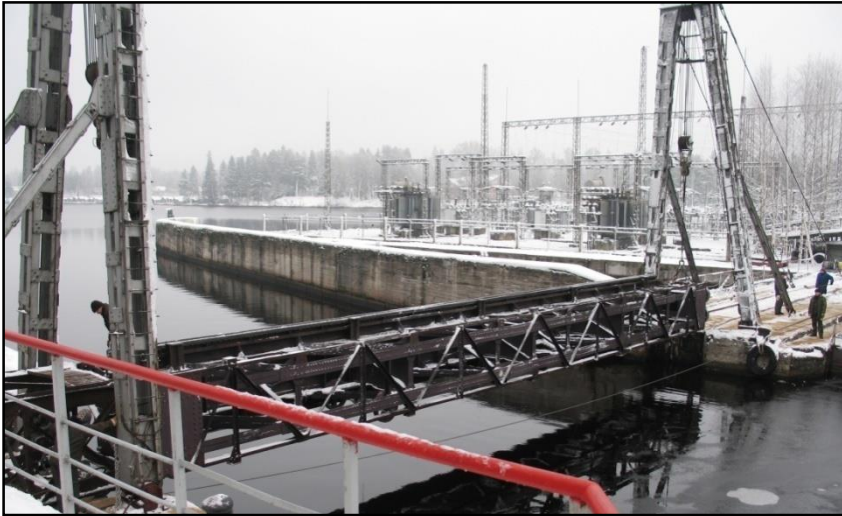
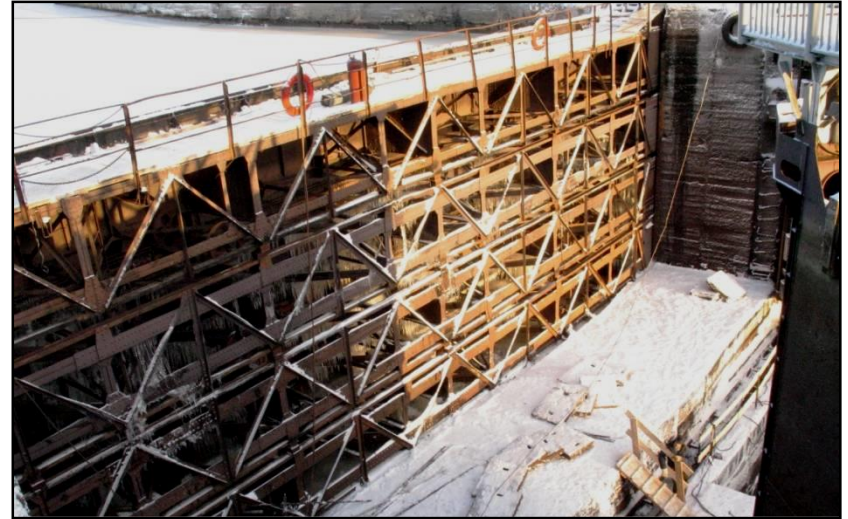
## An emergency-bulkhead gate with hydroelectric drive has been mounted in 2010

**2007:** A headrace water shutoff and leakage elimination takes 250 hours

**2010:** A headrace water shutoff takes 10 minutes

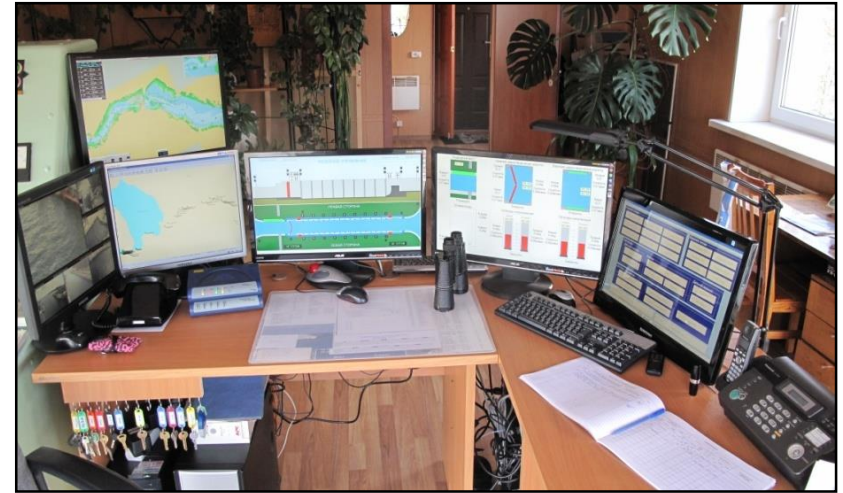
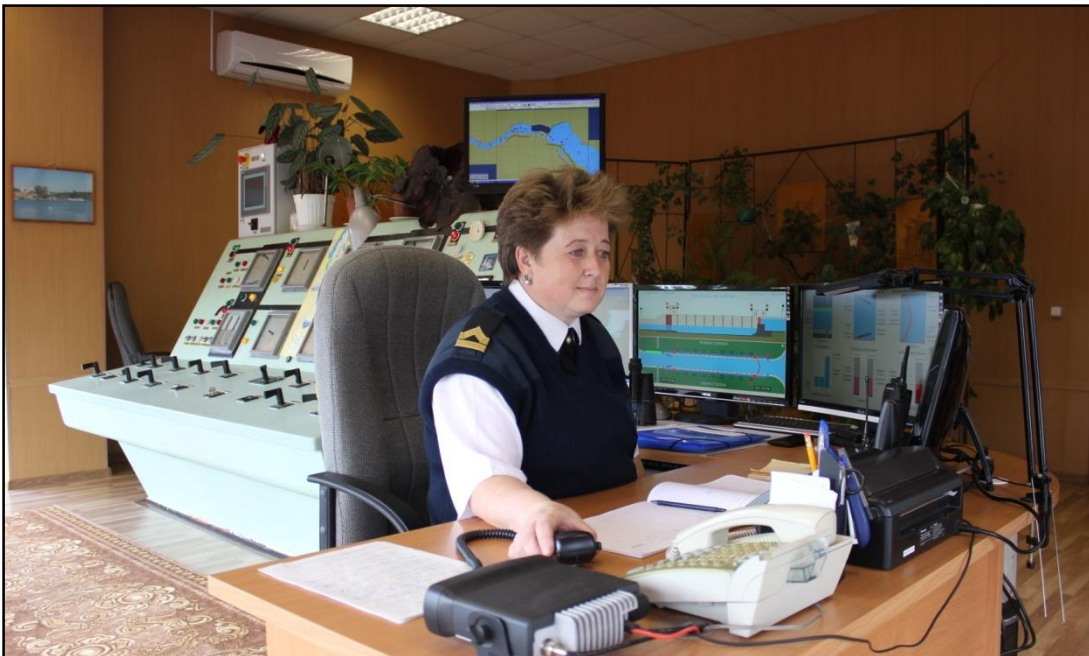
Relay-contactor control system  
(electromechanical switching)

Computer-driven control system

In case of failure of computer control system an automatic fallback to the relay-contactor system occurs

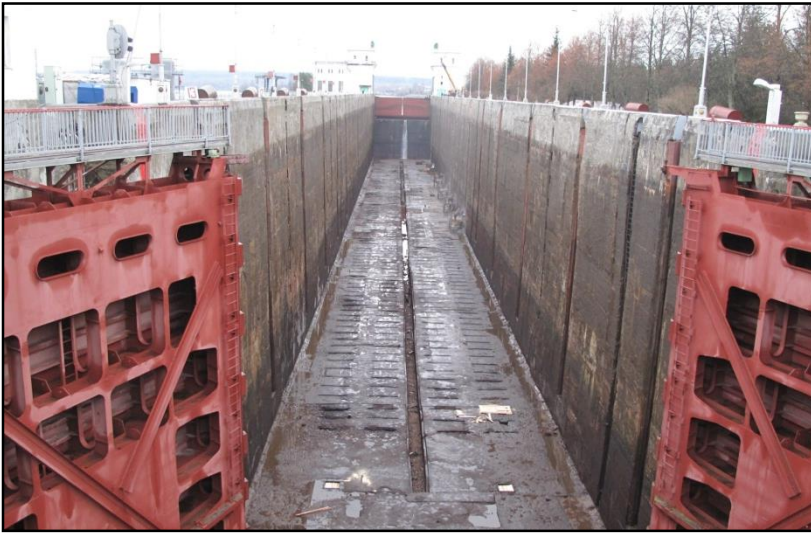
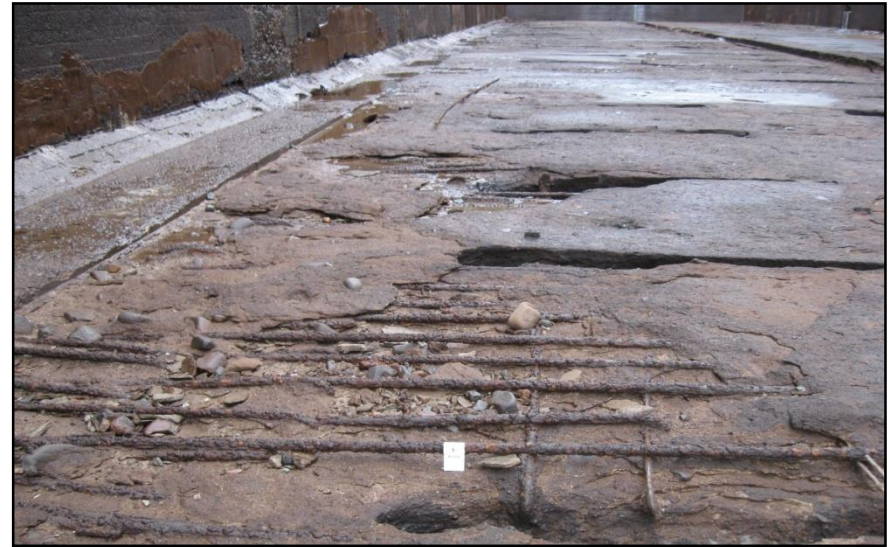
2010

# A chamber bottom repairing of the Upper Svir lock has been executed

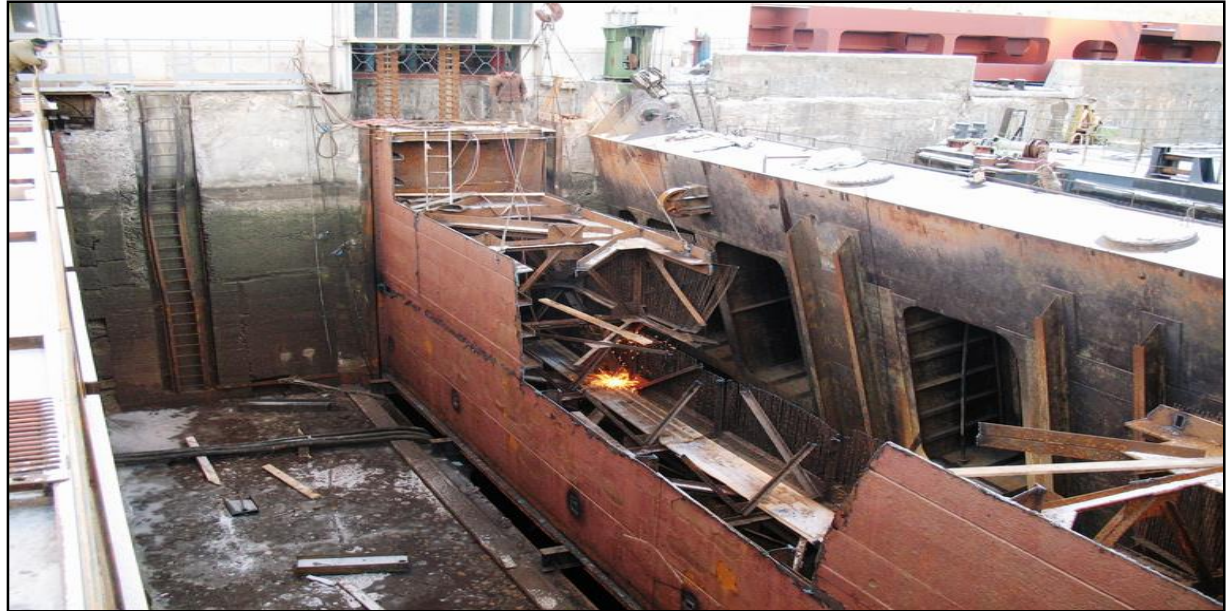
**2006**

**Demounting of the old gate  
(53 y.o. !)**

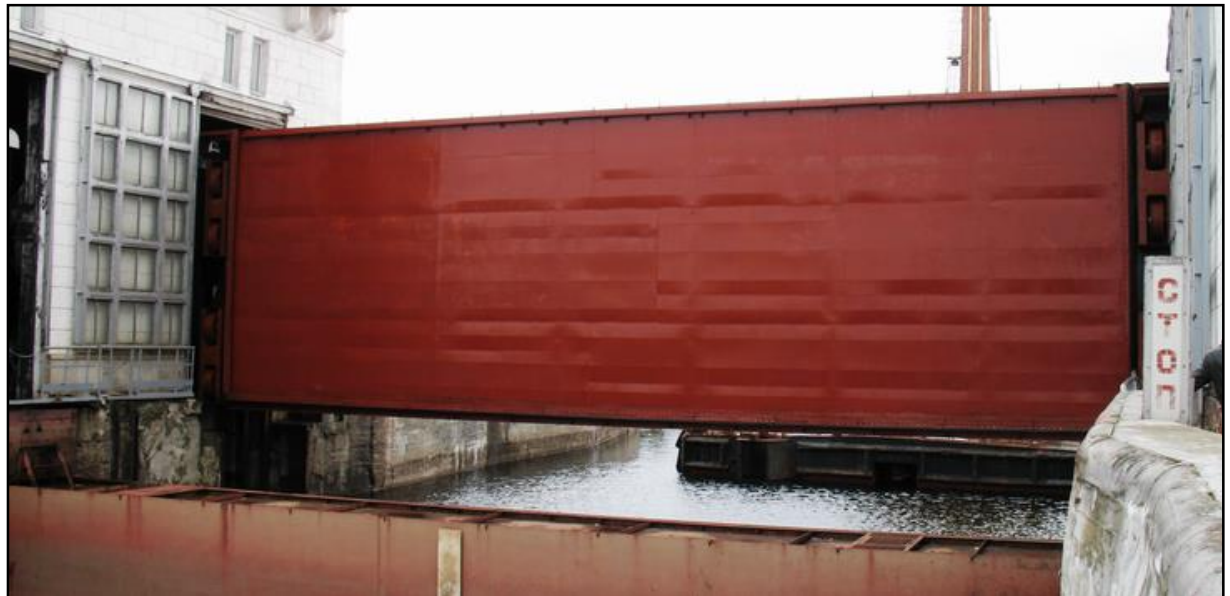
**2007**

**The gate has been substituted**

**A water pressure protection  
is assured**

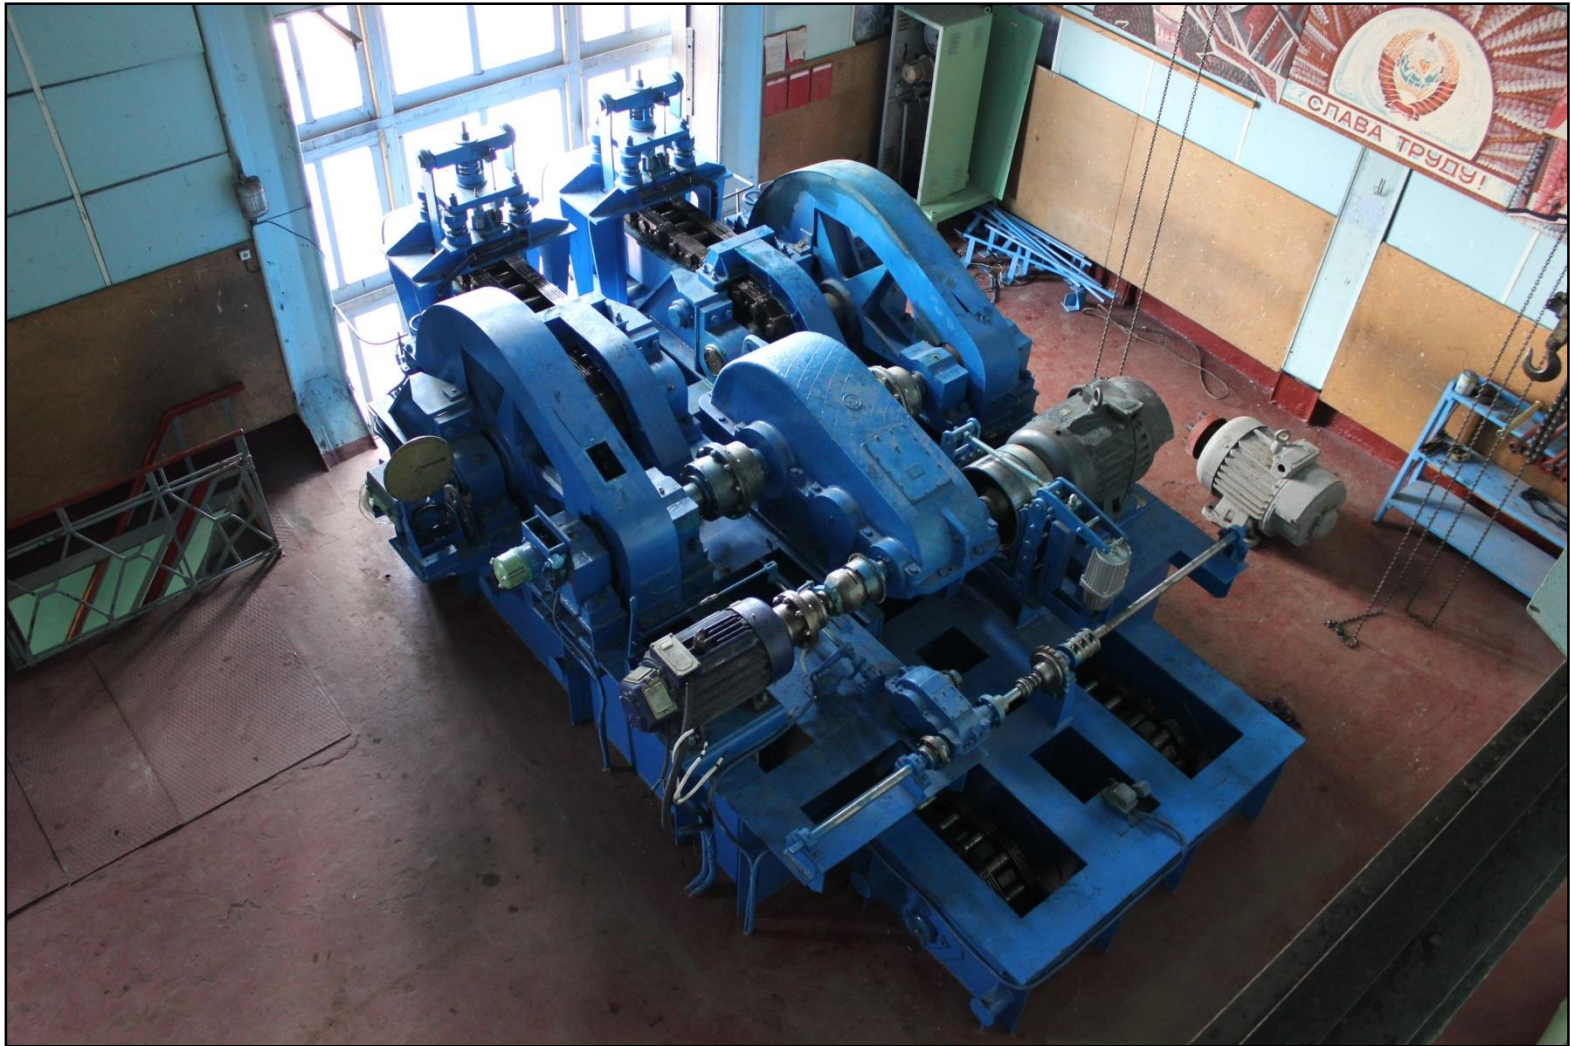
**All the engines of the gates, paddles and turning bridge have been replaced**

The engine of the emergency-bulkhead gate

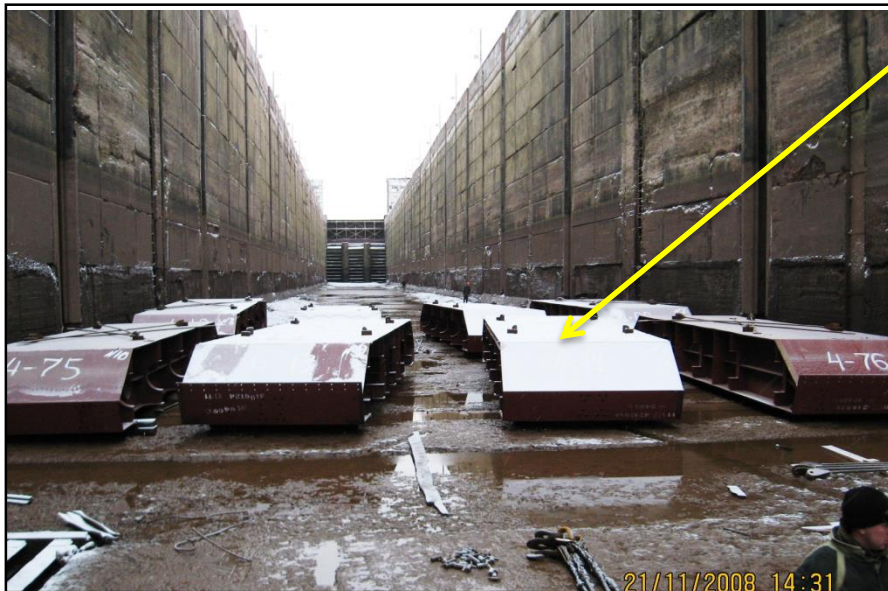
Lock chamber after discharge

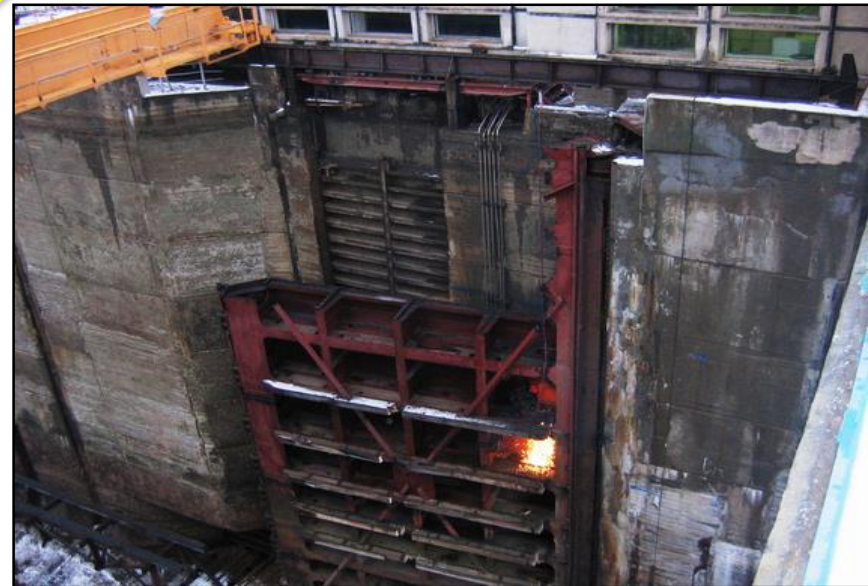
Demounting of old gates

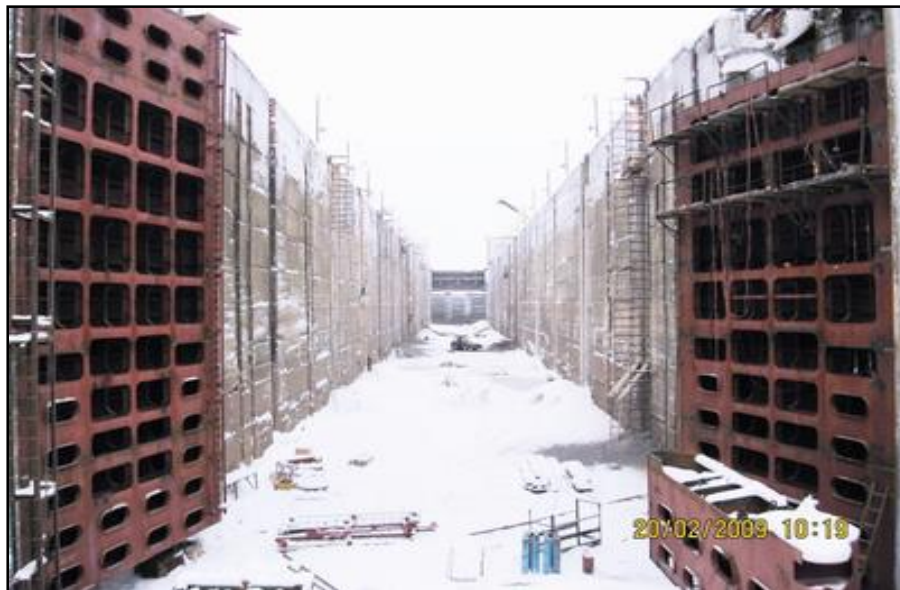
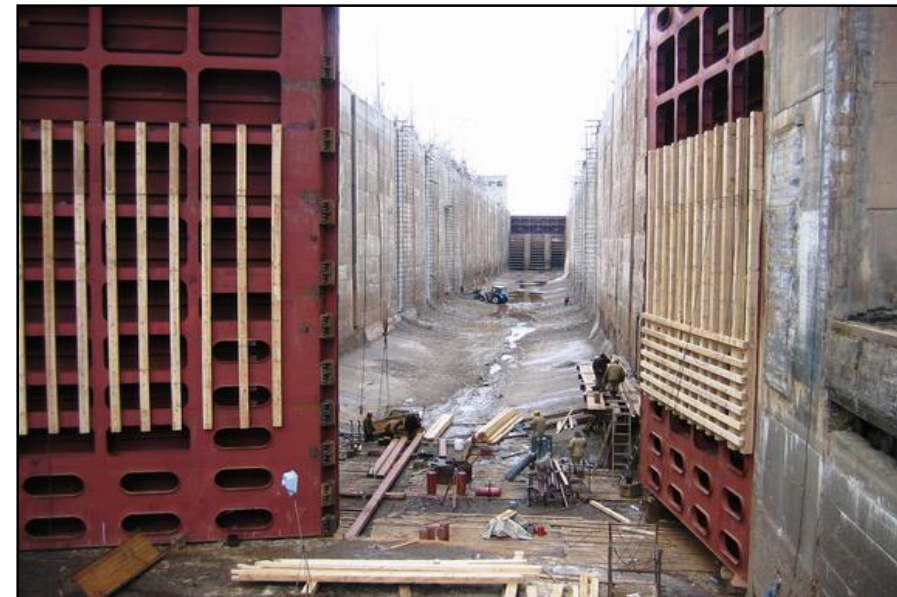
Mounting of new gates

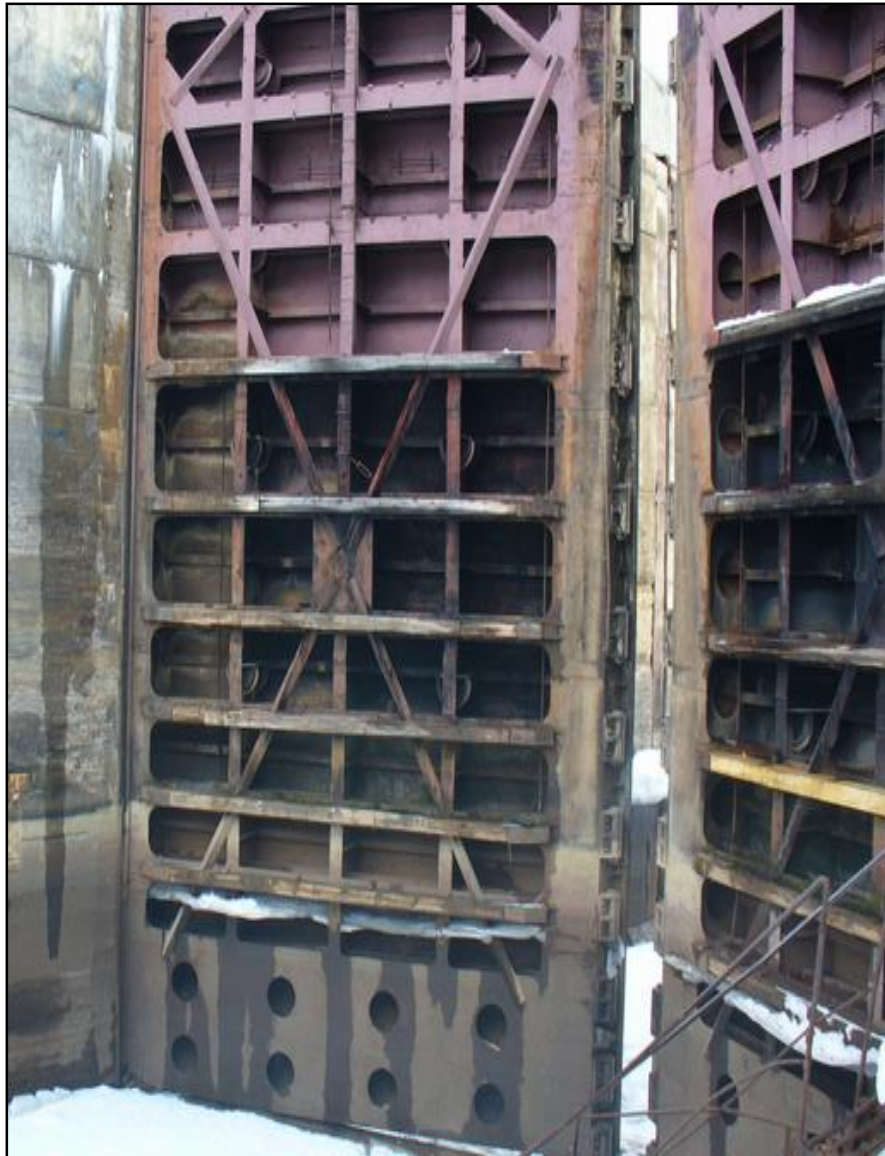
Old gates

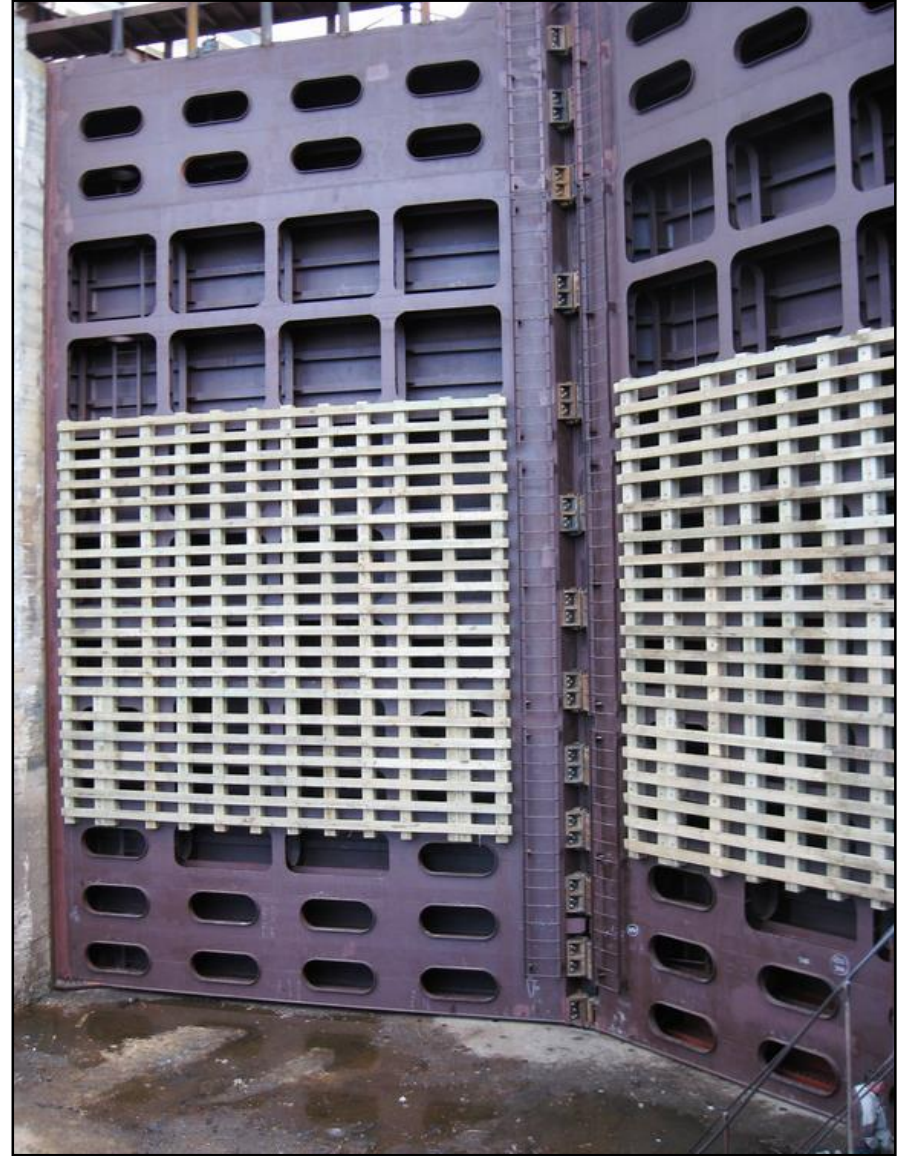
New gates

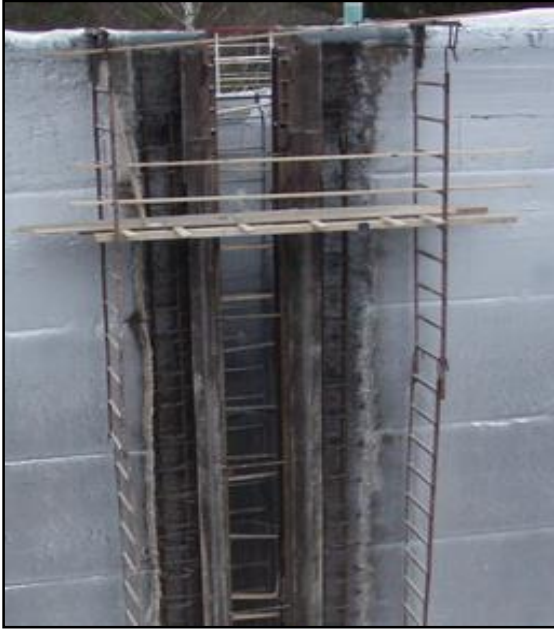
1) Disassembling of concrete

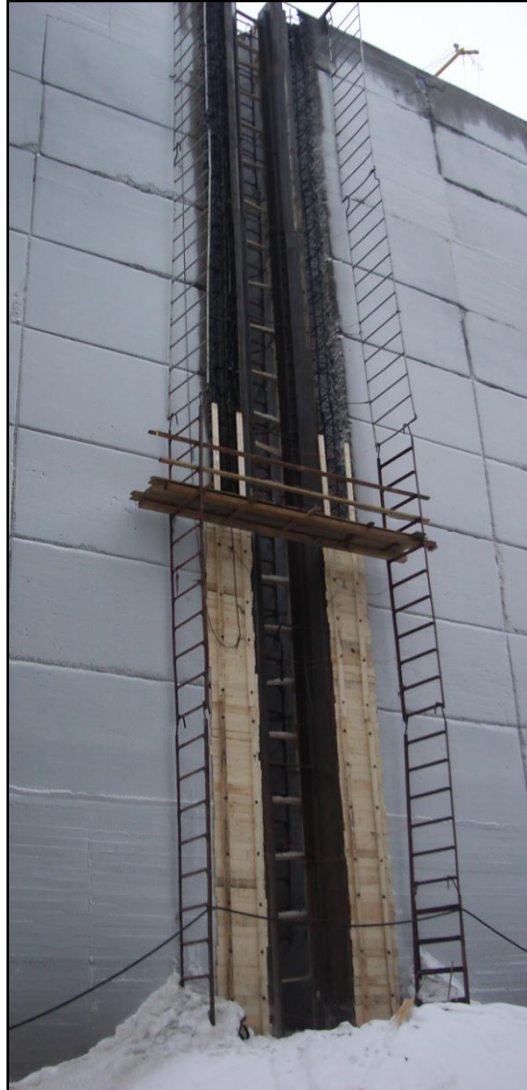
3) Casing and concreting

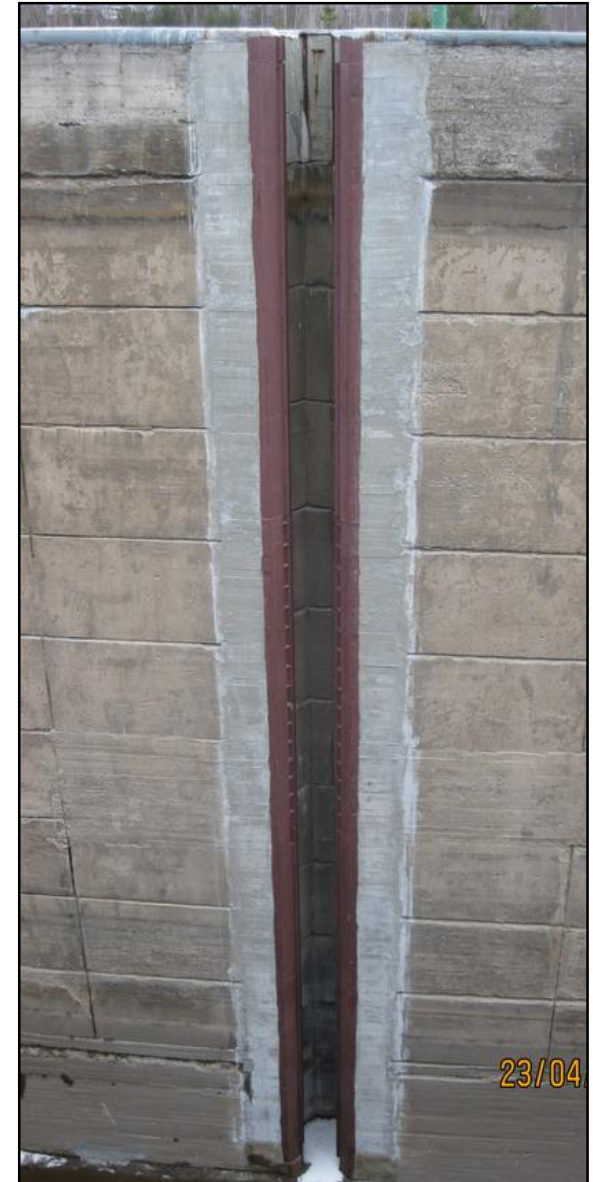
4) Action done !

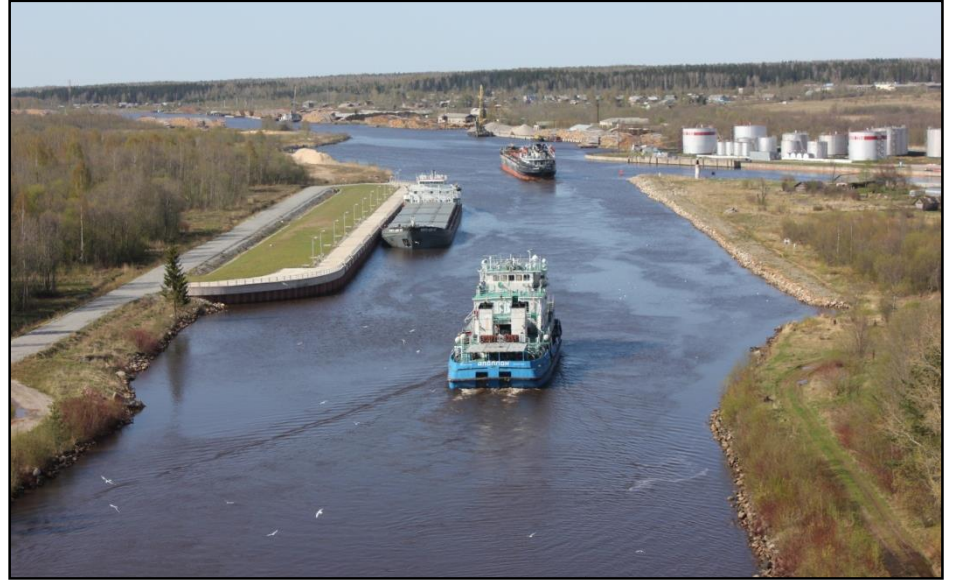
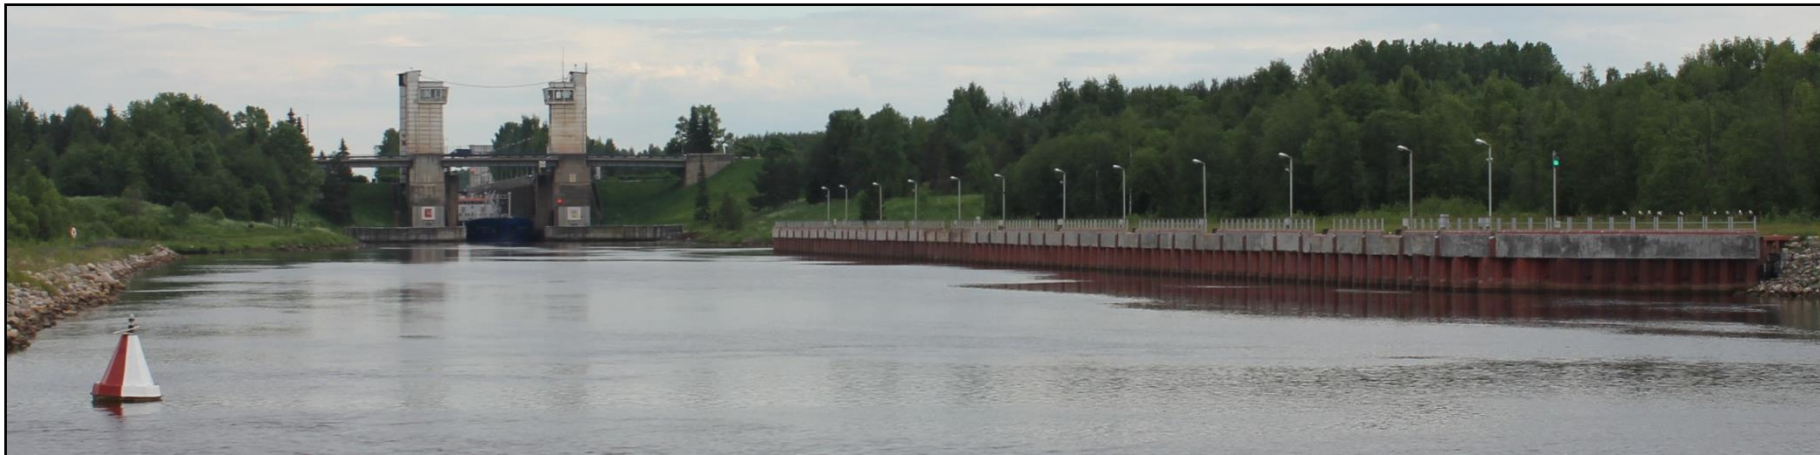
## Reconstruction of the moorage wall at the Lock №1 tailrace access duct

**2008:** the fairway width is 40 m.;  
Passage of 2 vessels is prohibited !

**2010:** the fairway width is 64 m.;  
passage of 2 vessels is allowed !  
A lockage time saving is 15 minutes

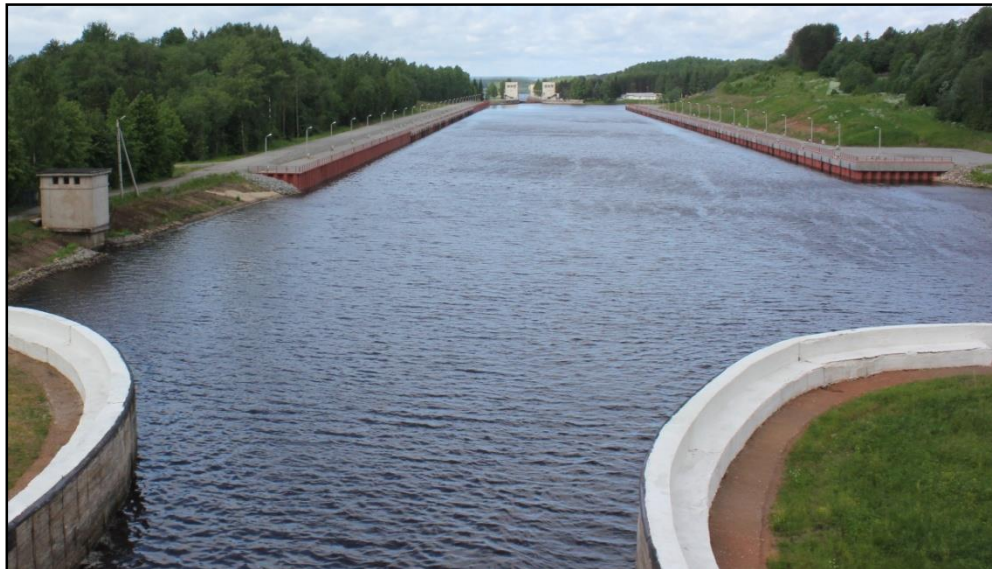
## The guiding and mooring walls have been built between Lock №3 and Lock №4

**2008:** the fairway width is 46 m.;  
Passage of passenger vessel by large-  
capacity vessel or convoy is prohibited !

**2010:** the fairway width is 80 m.;  
Passage of all types of vessels is allowed !  
A traffic capacity growth is 20%
